An overview of recent large catastrophic landslides in northern British Columbia, Canada

Marten Geertsema^{a,*}, John J. Clague^b, James W. Schwab^c, Stephen G. Evans^d

Abstract

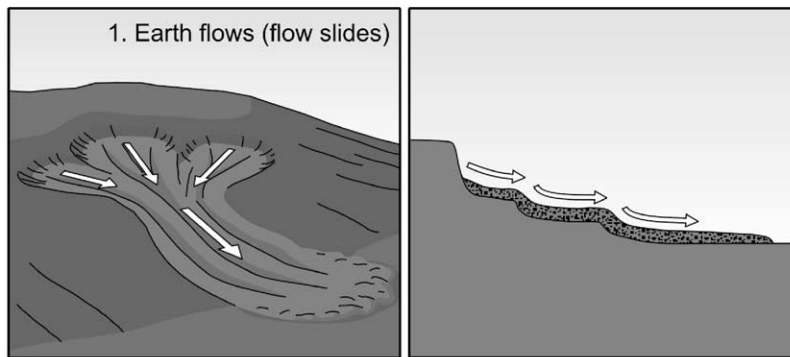
A) Long runout landslides in rock

B) Long runout landslides in soil

C) Long runout landslides in rock and soil

Fig. 2. Landslide types described in this study.

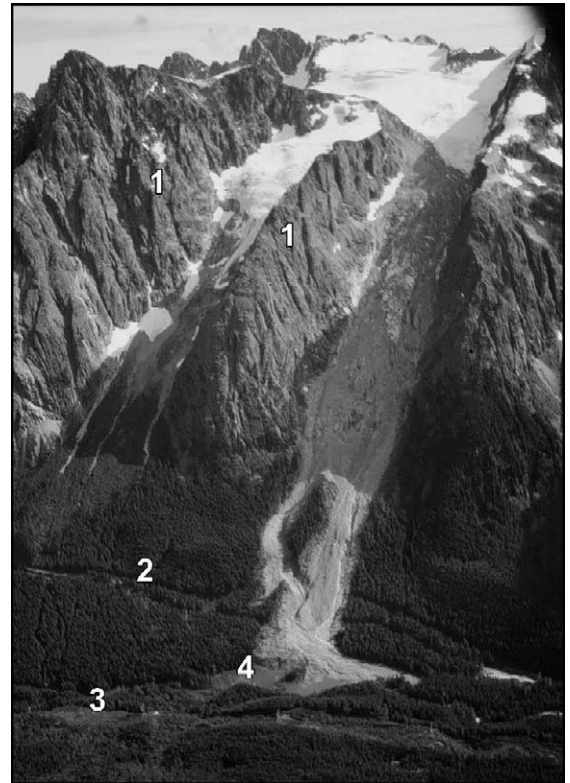
Fig. 4. Howson rock avalanche. Note cliffs (1), pipeline (2), powerline (3), and new lake (4).

Most, but not all, of the rock avalanches terminated on glaciers. The landslides at Howson Range in 1978 and 1999 (Schwab et al., 2003) reached the valley floor at Telkwa Pass and ruptured a natural gas pipeline, disrupting service to the communities of Kitimat, Prince Rupert, and Terrace. The Howson landslides generated type II dams, and the lakes persist to this day.

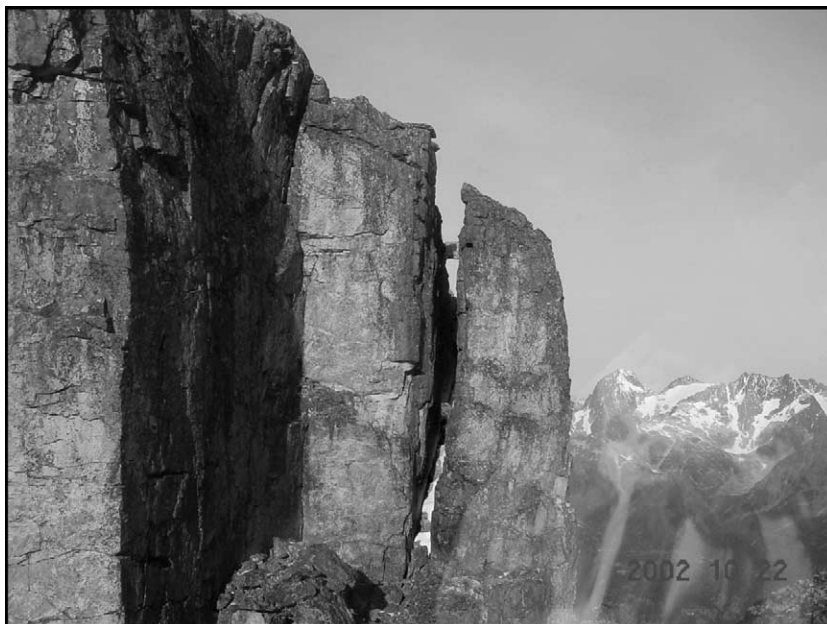
Fig. 3. Vertical joints that have opened in response to debuttressing adjacent to Howson Glacier west of Smithers.

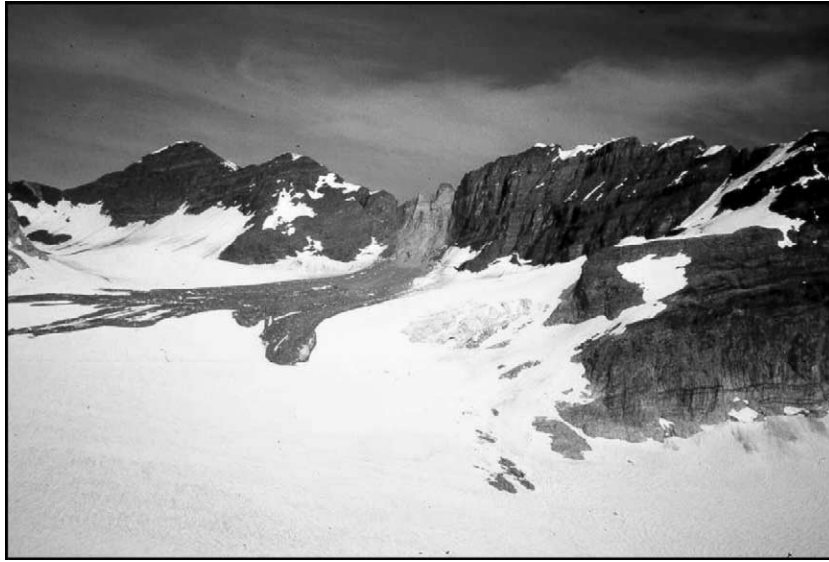
Fig. 5. Rock avalanche at Kendall Glacier, 45 km northwest of McBride. The runout length is 1200 m. Photo courtesy of Carl Erickson, BC Forest Service.

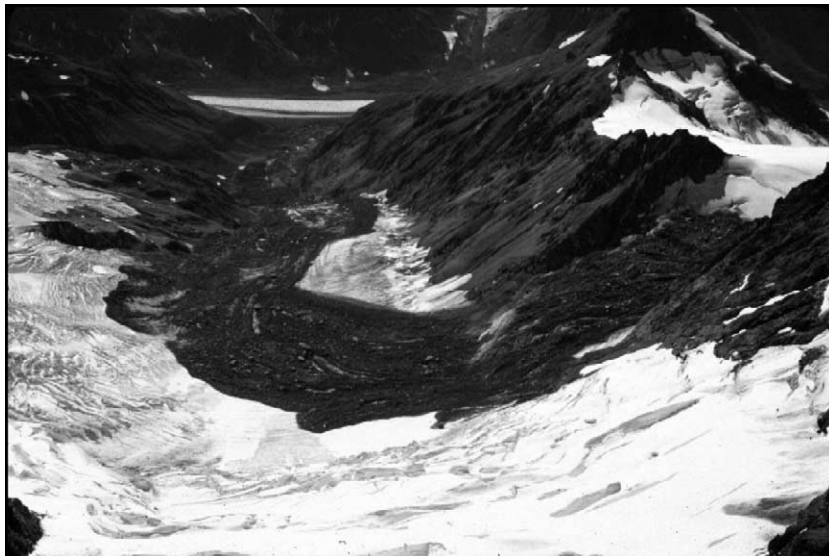
Fig. 6. Large rock avalanche at Frobisher Glacier, Saint Elias Mountains, northwestern British Columbia.

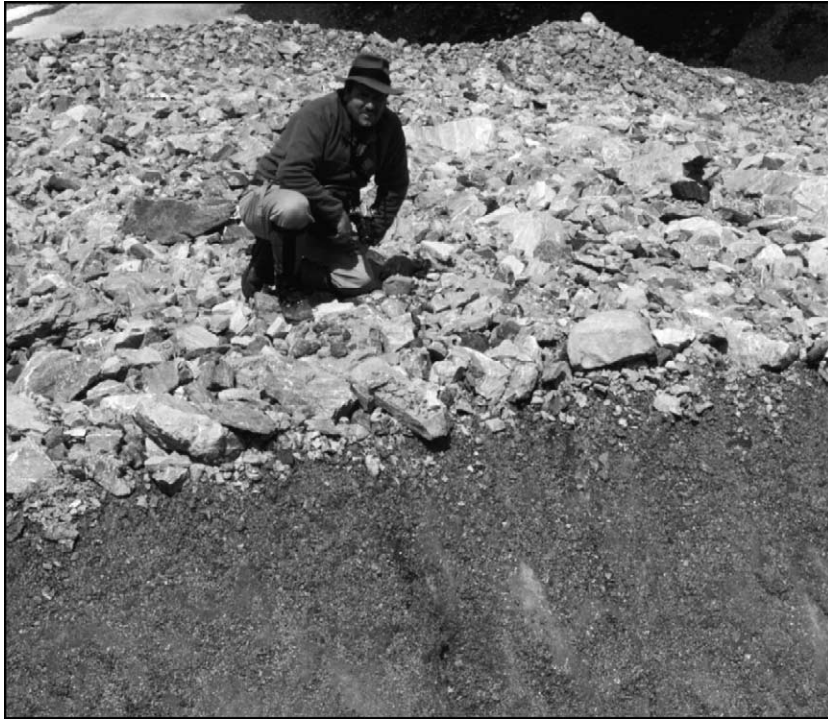
Fig. 7. Thin rock avalanche debris covering Jarvis Glacier. The landslide was triggered by a magnitude 7.2 earthquake in southeastern Alaska in 1979.

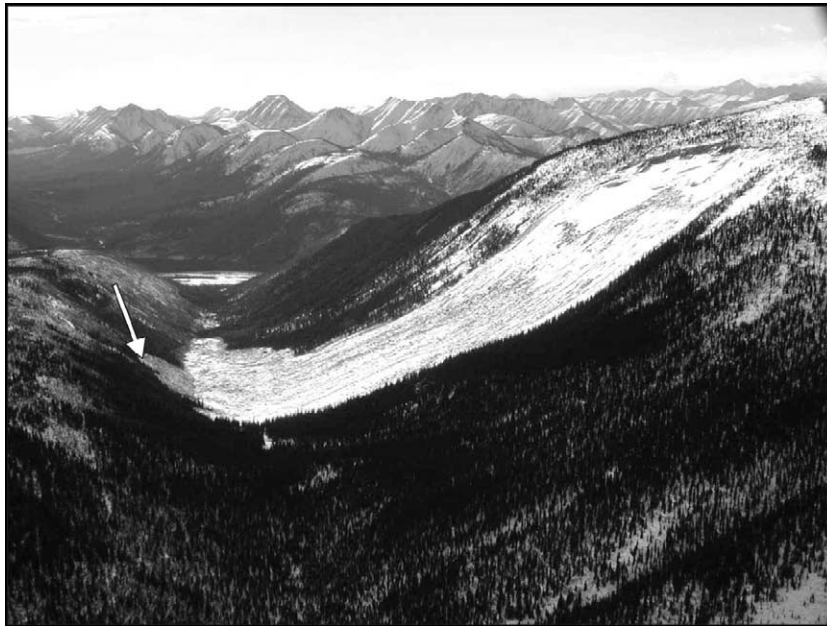
Fig. 9. The 1988 Tetsa rock avalanche in the foothills of the northern Rocky Mountains. The runup (arrow) on the slope opposite the detachment zone is 100 m.

The 1988 Tetsa rock avalanche (Fig. 9) and 1996 Chisca rock avalanche (Fig. 10) occurred on sedimentary dip slopes of 27° to 36° in the Rocky Mountain Foothills in northeastern British Columbia (Fig. 1; Table 1). They involved Permian to Carboniferous sedimentary rocks (Kindle Formation) and appear to be associated with fault zones (MacIntyre et al., 1998). The deposits of the two rock avalanches consist primarily of highly fragmented, angular sandstone rubble, with minor amounts of shale (Fig. 11). Rafts of soil and forest floor materials were noted on top of the rubbly debris.

Fahrböschungen (Table 1) are relatively low: 14.0° and 13.5° for the Tetsa and Chisca landslides, respectively. The Tetsa landslide initiated at 1500 m asl, descended to 940 m asl, and ran 100 m up the opposite slope. The total travel distance is 2240 m. The Chisca landslide ran out onto saturated permanently frozen organic soil (muskeg) with a 60 cm thick active layer. Its low H/L ratio (Fig. 8) likely relates to these conditions.

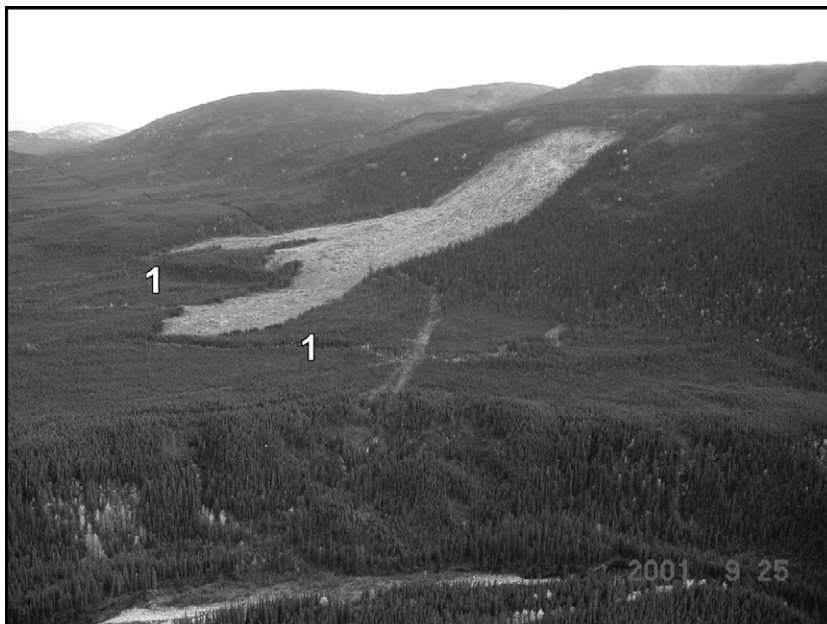
Fig. 10. The 1996 Chisca rock avalanche on a dip slope in the Rocky Mountain Foothills. The landslide ran out on to permanently frozen muskeg (1).

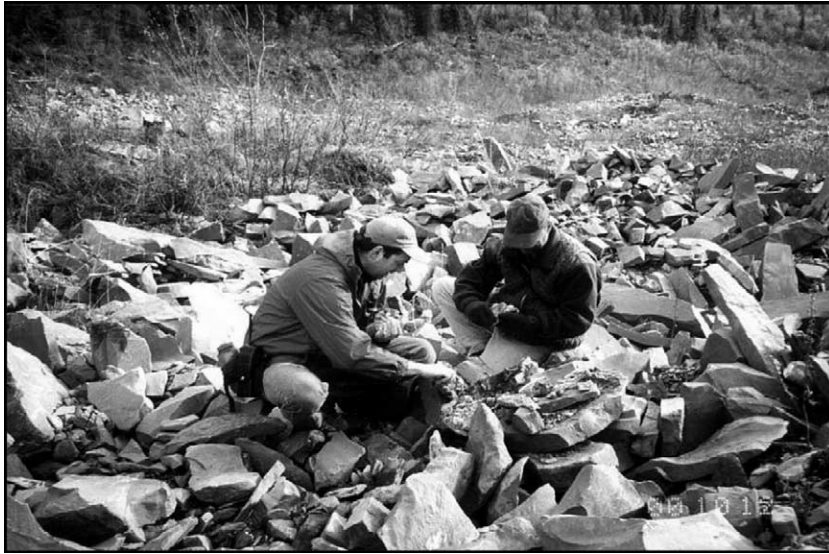
Fig. 11. Angular sandstone rubble of the Tetsa rock avalanche.

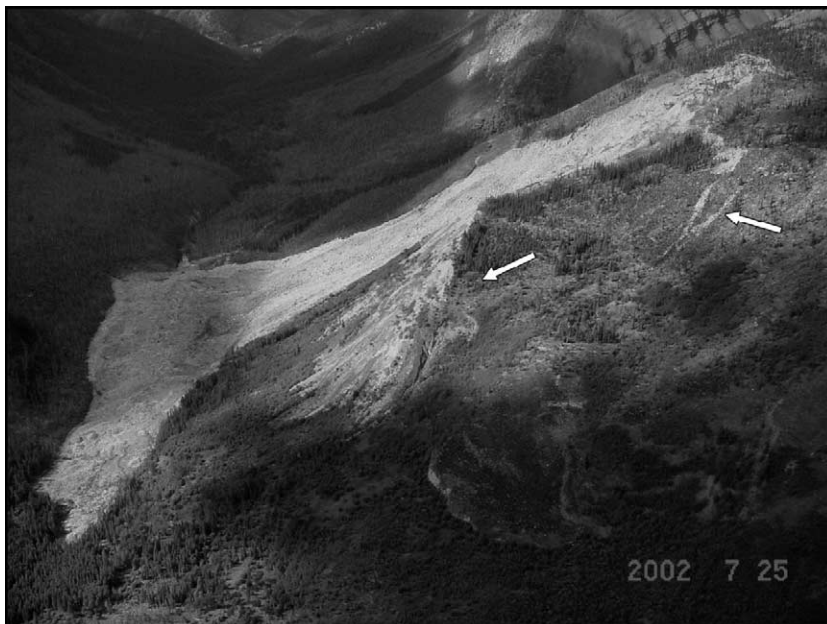
Fig. 12. The 1992 Turnoff Creek rock avalanche was associated with deep-seated mountain slope deformation (arrows).

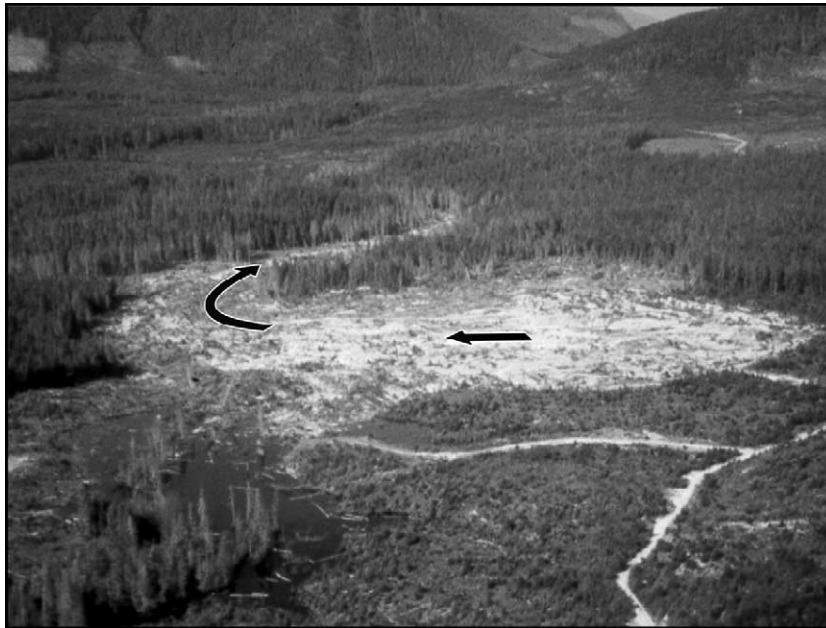
Fig. 13. Oblique aerial photograph of the 1994 Mink Creek flowslide near Terrace. Note the lake formed by the type II landslide dam and the nearly flat slope of the landslide.

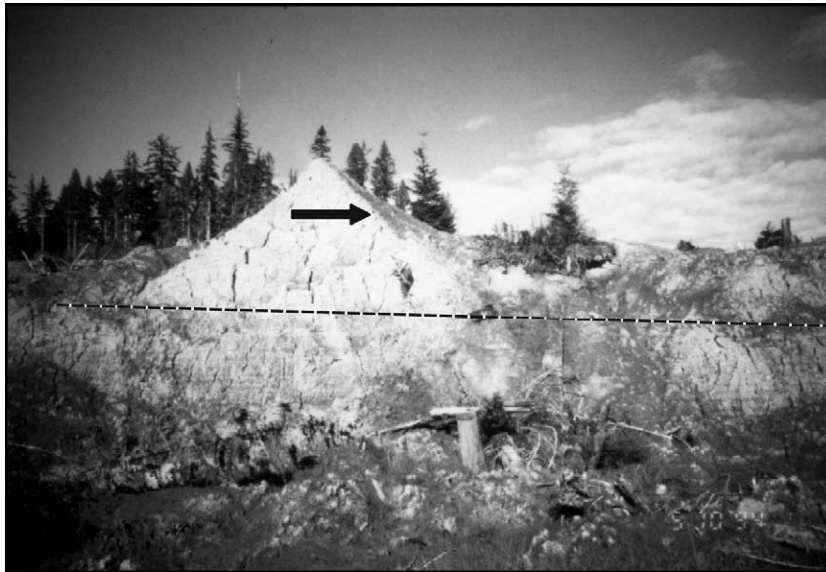
Fig. 15. Prism of glacial marine sediments in the Mink Creek landslide. The prism is part of a transverse ridge that formed by translational movement along a nearly horizontal rupture surface (dashed line). Arrow indicates direction of movement.

Creek. The Mink Creek landslide shows evidence of both spreading (Fig. 15; Eden et al., 1971; Evans and Brooks, 1994) and flowing (Geertsema et al., 2006-this issue-a). The Khyex River landslide is a flow, with few transverse ridges (Schwab et al., 2004). Examples of similar flows include the 1971 St. Vianney landslide in Québec (Tavenas et al., 1971) and the Rissa landslide in Norway (Gregersen, 1981).

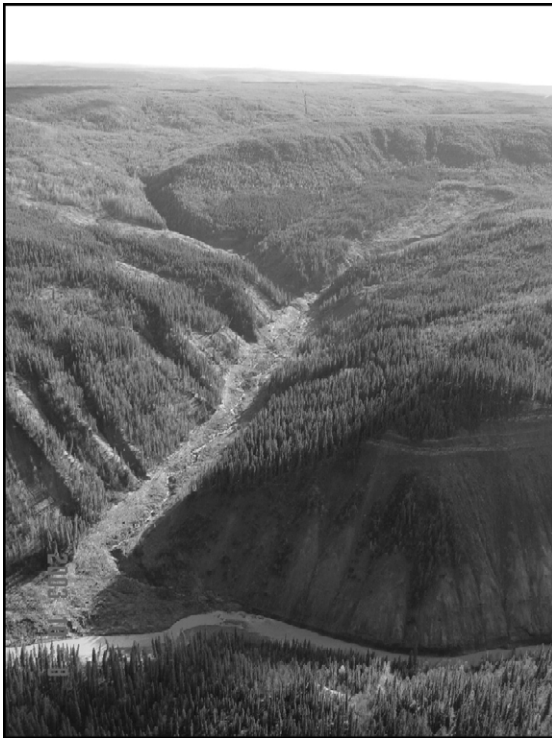
Fig. 19. Two coalescent flows in diamicton at Buckingham River (foreground). The travel distance is greater than 1.7 km.

The Buckinghamshire River landslides (Figs. 19, 20) are retrogressive and extremely mobile, with travel distances up to 1765 m along gradients as low as 3° . The abundance of flowslides in this area in the 1990s suggests a climatic link. The warming trend at that time (Fig. 21) may have contributed to degradation of permafrost or to seasonal changes in precipitation that could have triggered landslides in the Buckinghamshire River basin.

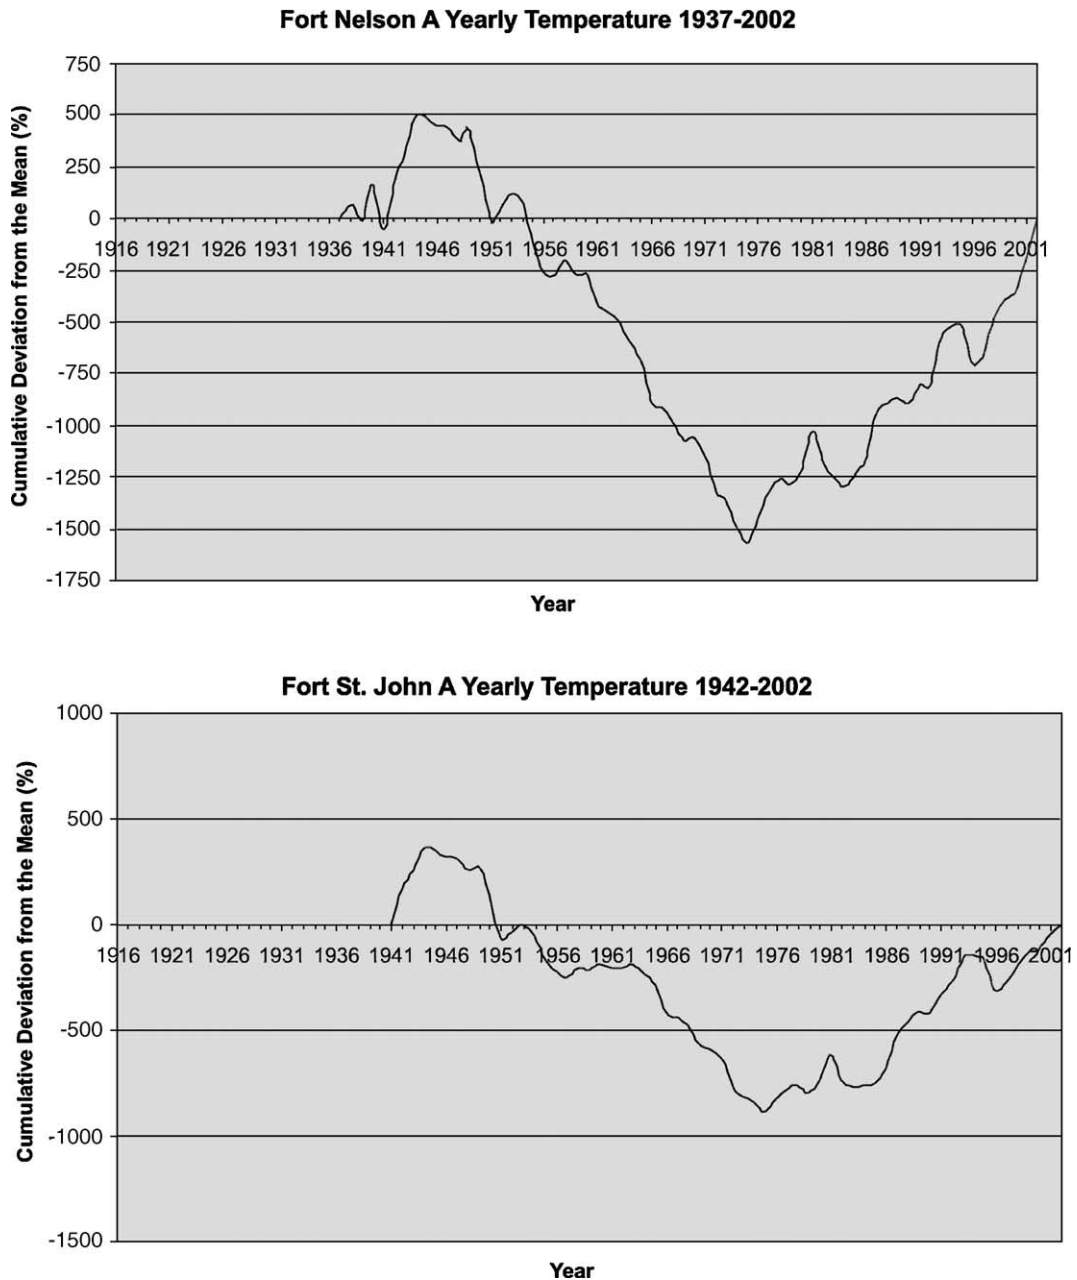
Fig. 21. Graphs of cumulative deviation of yearly mean temperature for Fort Nelson and Fort St. John. The graphs indicate nearly three decades of increasing temperature.

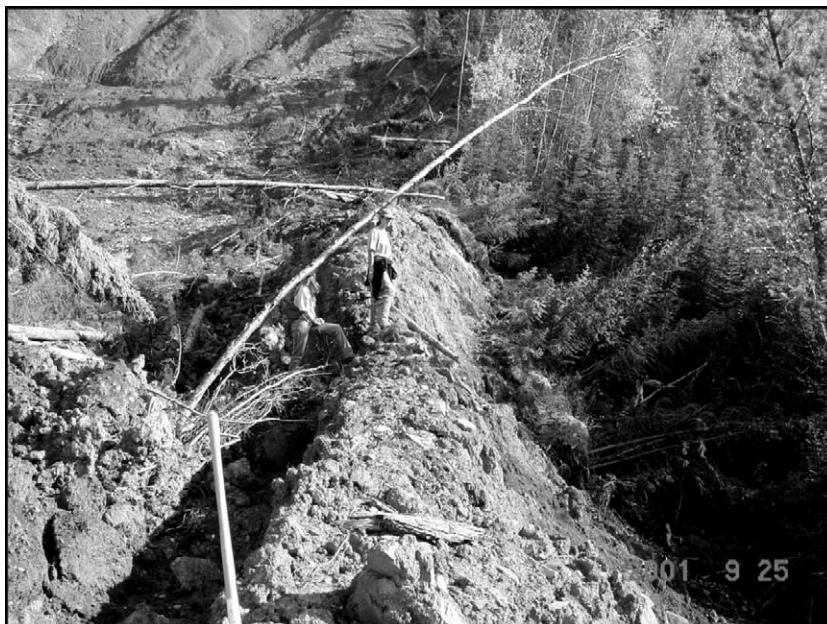
Fig. 24. Levee on the Muskwa–Chisca landslide.

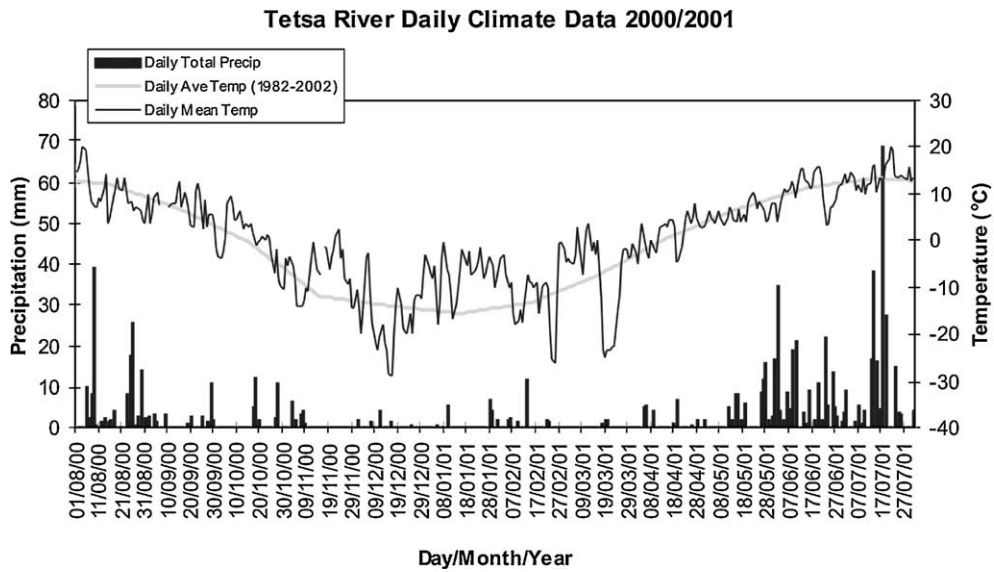
Fig. 25. Climate data associated with the Muskwa–Chisca landslide. The landslide may have been triggered by intense rainfall in July 2001.

The Muskwa–Chisca landslide occurred in July 2001 (Doug Mckee, Fort Nelson, personal communication, 2001). The landslide is 1.5 km long and covers an area of 43 ha. Heavy rains may have triggered the initial rotational failure (Fig. 25).

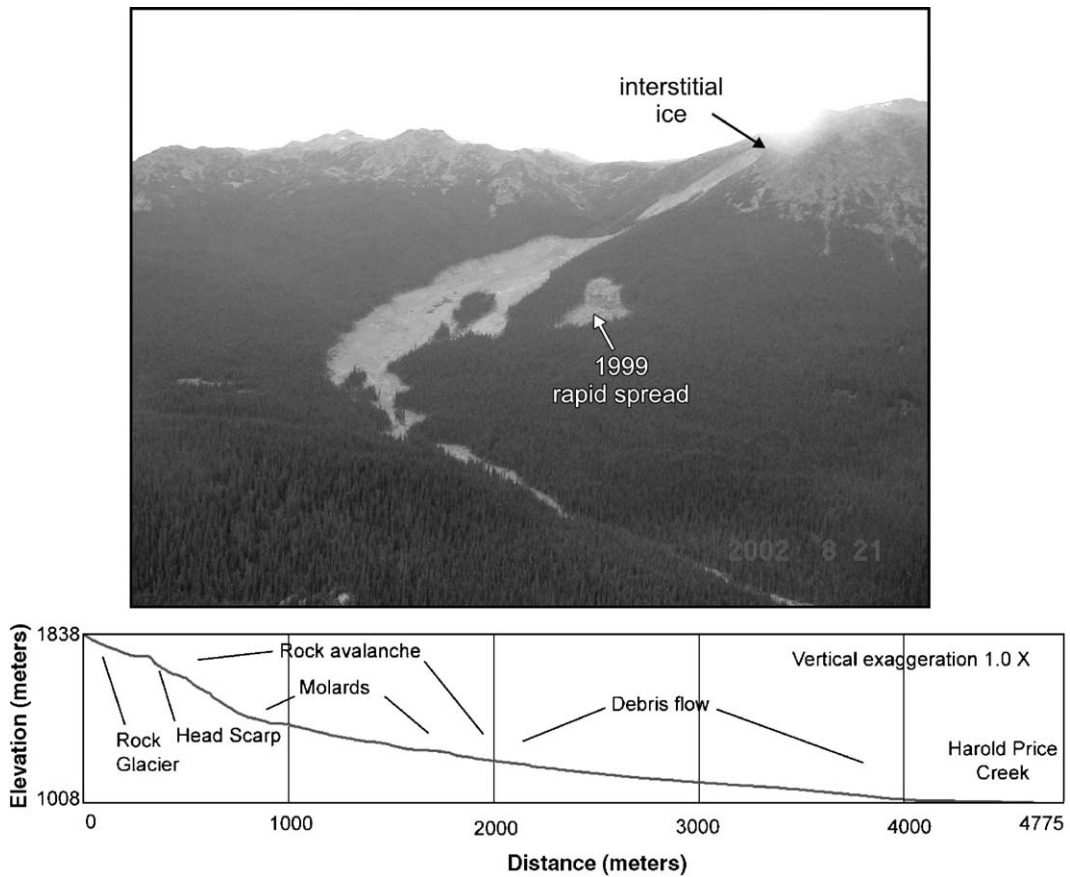
Fig. 26. Top: The 2002 Harold Price rock slide–debris flow. The smaller landslide to the right occurred in 1999. Bottom: profile of the landslide path.

Two large rock slide–debris flows occurred in north-western British Columbia in June 2002 (Schwab et al., 2003; Fig. 1; Table 1)—the Zymoetz (Copper) River landslide on 8 June (Boulton et al., 2006–this issue) and the Harold Price landslide (Fig. 26) between 22 and

The Harold Price landslide originated at 1723 m asl at the lip of a southwest-facing cirque occupied by a rock glacier. Interstitial ice was observed in the scarp face after the landslide. Debris dropped 300 m into the valley, expanding to a width of about 360 m and rapidly accelerating. After travelling 1.3 km, the landslide transformed into a debris flow, which became channelized 2.2 km from the source. The total travel length of the landslide is 4 km, but a hyper-concentrated flow carried sediments and logs an additional 3.5 km down Harold Price Creek. The volume of the landslide is about 1.6 M m^3 and its *fahrböschung* is 9.9° .
