Landslides in the Vancouver-Fraser Valley-Whistler region

S.G. Evans¹ and K.W. Savigny²

Evans, S.G. and Savigny, K.W., 1994: Landslides in the Vancouver-Fraser Valley-Whistler region; in Geology and Geological Hazards of the Vancouver Region, Southwestern British Columbia, (ed.) J.W.H. Monger; Geological Survey of Canada, Bulletin 481, p. 251-286.

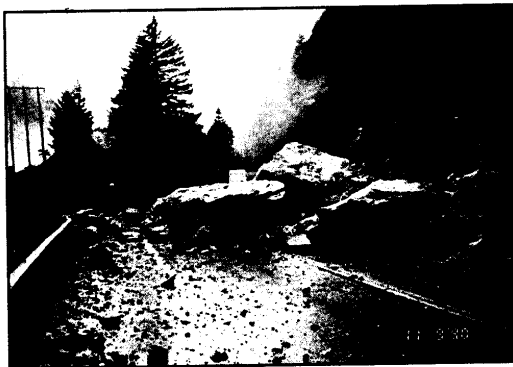
Figure 4. Rockfall on Trans-Canada Highway, Fraser Canyon, near Yale (courtesy of D. Wyllie).

Canadian Pacific Railway (CPR) and Canadian National Railway (CNR) (Fig. 4, 5), causing traffic delays, derailments, and numerous deaths. Since the 1960s, the B.C. Highways Department and both railway companies have spent many millions of dollars to mitigate the rockfall hazard, either by rock slope treatment (e.g., scaling, rock bolts, shotcrete, buttresses, and drainage) or the construction of protective measures such as sheds, catch fences, meshes, ditches, and warning devices (Peckover and Kerr, 1977; Wylie, 1991).

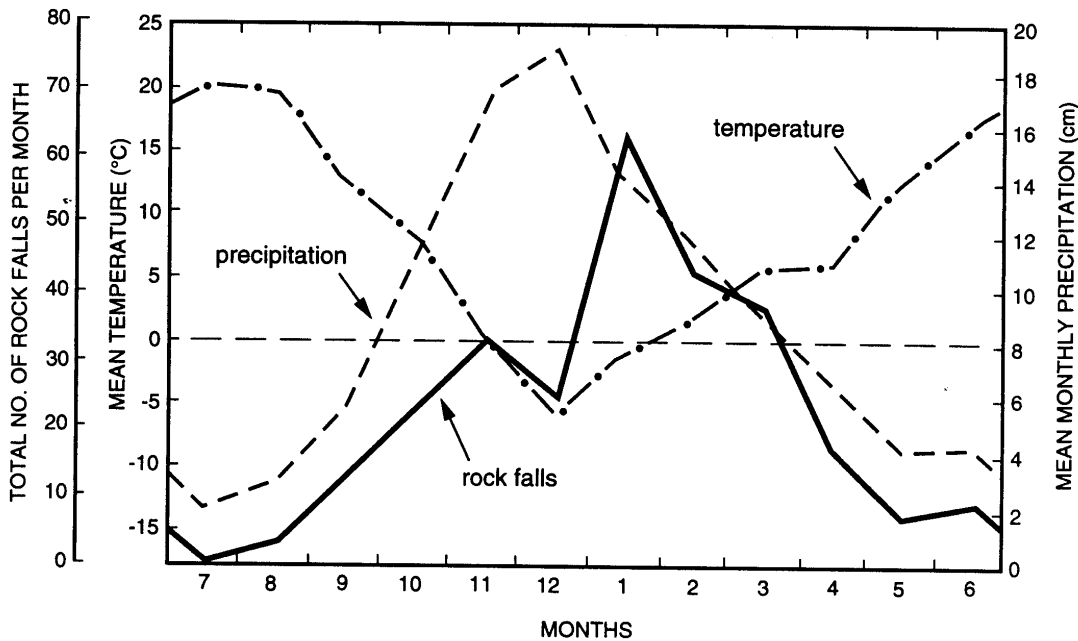
Figure 6. Rockfall frequency and weather over the period 1933-1970, Fraser Canyon, Yale subdivision, Canadian National Railway (modified from Peckover and Kerr, 1977).

Rockfall frequency shows a marked correlation with the weather (Peckover and Kerr, 1977; Fig. 6). Figure 6 shows data for rockfall frequency on Canadian National Railway tracks in the Fraser Canyon. The highest frequency is found in January, February, and March, the time when freeze-thaw cycles are most frequent, thus reflecting the role of frost wedging in rockfall release. When the mean monthly temperature is above zero (March–November), the number of rockfalls per month varies more or less directly in proportion to mean monthly precipitation (Peckover and Kerr, 1977).
