### Cheam slides

### Mystery Creek

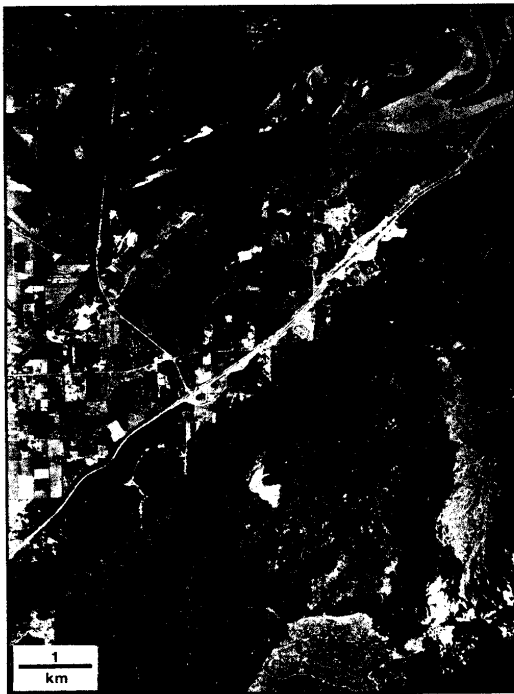
**Figure 14.** Airphoto of Cheam slide(s), Fraser Valley. Both source area (S) and extent of debris (D) have yet to be defined in detail. The debris is crossed both by the Canadian National Railway and the Trans-Canada Highway. Radiocarbon dates quoted in text were obtained from wood in debris in pit marked P. Fraser River (F) and flow direction are indicated. NAPL A27109-40

Cheam slide is a prehistoric rock avalanche complex located on the southeast side of the Fraser River valley 20 km east of Chilliwack (Fig. 1 and 14). The landslide debris forms a hummocky surface which contrasts sharply with the surrounding flat Fraser Lowlands and the adjacent steep slopes of the North Cascade Mountains. The landslide was first examined by Smith (1971); the debris was mapped by Armstrong (1980) as a slope deposit. Naumann (1990) undertook a detailed assessment of both the source and deposition areas and Naumann and Savigny (1992) reported a detailed numerical analysis.

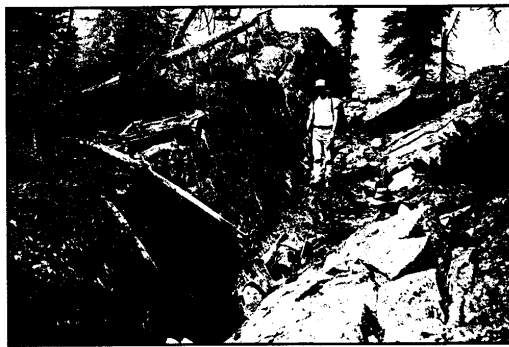
**Figure 16.** Antislope scarp formed by toppling on southern margin of Mystery Creek rock avalanche. Downslope is to the left. GSC 1994-709E

Detachment on a low angle ( $18^\circ$ ) joint surface dipping out of the slope appears to have been preceded by toppling toward the Green River valley involving flexural slip on steep foliation surfaces dipping into the slope (Evans, 1992a). Antislope scarps formed by toppling are present in displaced rock masses along the southern margin of the scar (Fig. 16). The characterization of the process by which this type of slope deformation terminates in catastrophic detachment remains a current research problem in géotechnique.

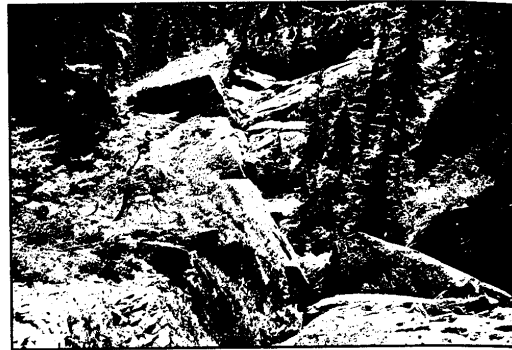
*Figure 21. Displaced rock masses resulting from mountain slope deformation, Mt. Breakenridge, Harrison Lake. GSC 1994-709G*
