LANDSLIDES IN PLEISTOCENE SEDIMENTS

DISCUSSION AND CONCLUSIONS

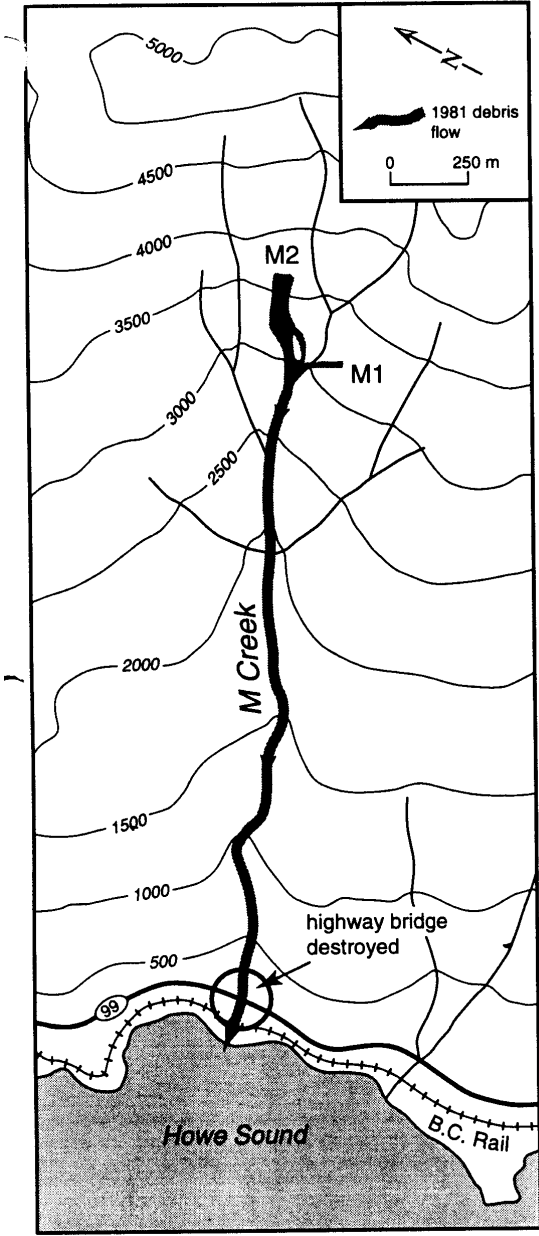
Figure 36. Map of M Creek debris flow which occurred on October 28, 1981, 2.5 km north of Lions Bay, east side of Howe Sound; M1 and M2 are probable source landslides for the debris flow (modified after Bovis and Dagg, 1992).

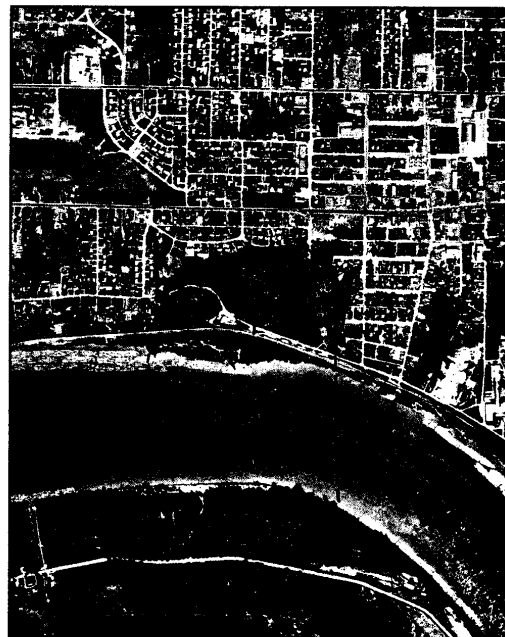
Figure 42. Airphoto of site of 1880 Haney landslide (from BC 7056-116).

Glaciomarine sediments are widespread in the Lower Mainland (Armstrong, 1984) but only one large landslide has occurred in these deposits in historical times. On January 30, 1880, a major landslide (estimated volume 10^6 m^3) occurred at Haney (Fig. 1) in glaciomarine sediments on the eroding north bank of the Fraser River (Fig. 42; Evans, 1982). Eyewitnesses reported that they heard the cracking of the ground and watched as a "great .. moving mass of earth and trees...slid

into the Fraser River" (Victoria Daily Colonist, February 5, 1880). The slide partially blocked the Fraser River and resulted in the death of one person (killed by the 12 m high displacement wave caused by the slide). Substantial damage to docking facilities occurred along the Fraser River (Evans and Clague, unpublished data). Excess pore pressures within sandy interbeds in the sensitive glaciomarine silts and clays and erosion at the toe of the slope by the Fraser River are probable causes of the slide (Evans, 1982).
