SCIENTIFIC REPORTS

Erosion and sedimentation during the September 2015 flooding of the Kinu River, central Japan

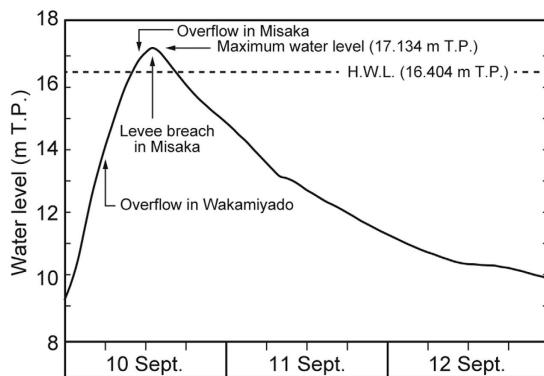
Figure 2. Hydrograph for the Kinu River at the Mitsukaido gauging station (Fig. 1B) from 10 to 12 September 2015. Measured water levels³⁷ were expressed compared to Tokyo Peil (T. P.; mean sea level in Tokyo Bay). H.W.L. means High Water Level at this station, a threshold height for flooding relative to the neighboring levee height.

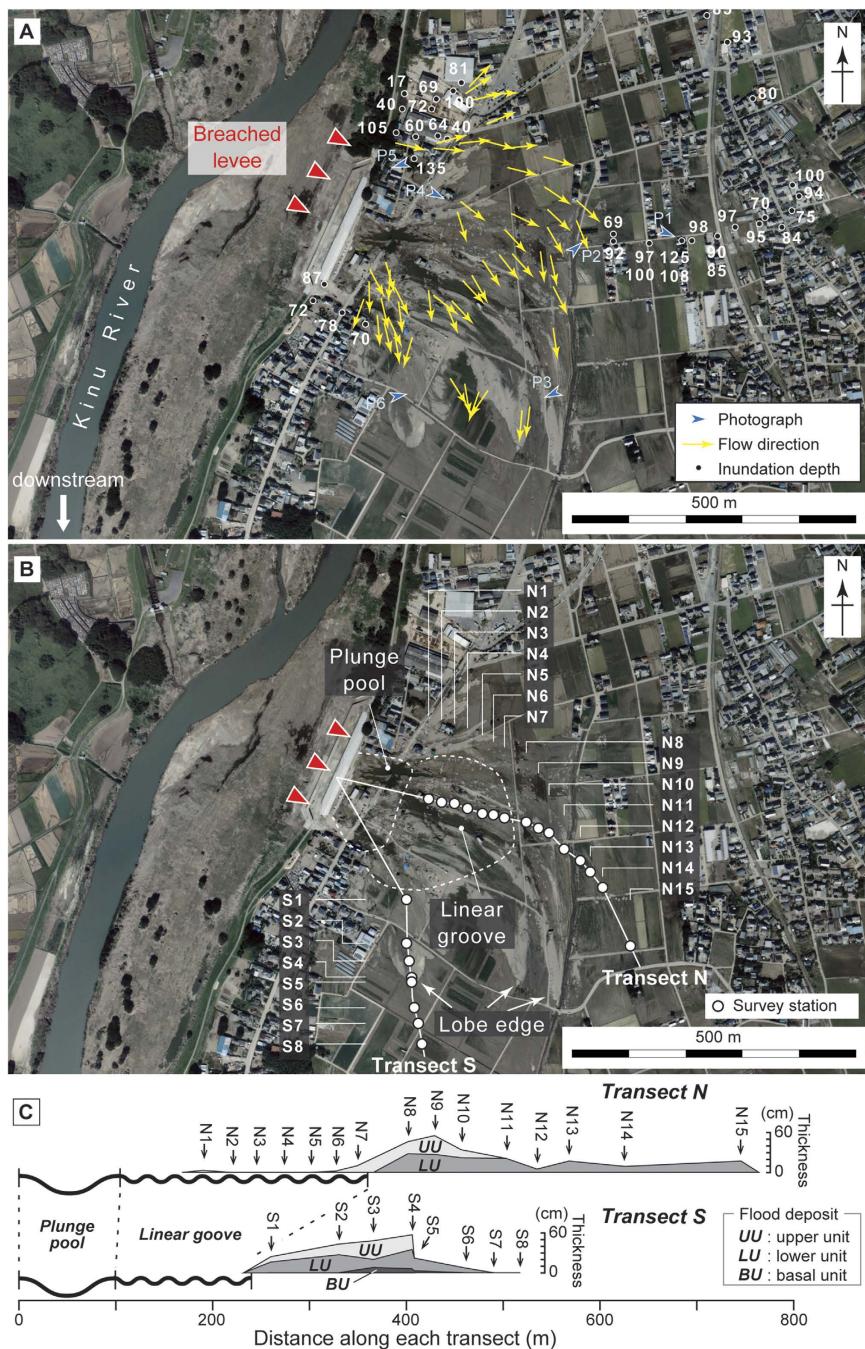
Figure 3. Detailed map of the survey sites with panels A and B displaying the same area. The aerial photo was obtained from the Geospatial Information Authority of Japan³⁸ (CKT-2015-12-C4-14) and taken on 29 September, 2015. (A) Map showing the survey locations on the photograph (blue arrowhead; Fig. 4), flow direction (yellow arrow) and inundation depth (black circle with the measured depth). (B) Map showing the survey stations where erosional and depositional features along Transects N and S were investigated. Transects N and S start at the breached levee and extend in the direction of flow. (C) Sectional view of the lateral distributions of erosional and sedimentary features along each transect from the breached levee. Note that erosional depths are not to scale.

The water depth during flooding, deduced from water marks and water-borne debris (Fig. 4A), was generally constant at most of the surveyed locations within the study area and ranged from 17 to 135 cm (83 cm on average) (Fig. 3A). Leaning plants, bedforms, and erosional scours (Fig. 4B–D) indicated an ESE–SSE flow direction that was perpendicular to the Kinu River flow in the area next to the breached levee (Fig. 3A). With increasing distance away from the breached levee, the direction of the flow gradually turned southward (Fig. 3A).

Numerous geomorphological features of erosion and sediment deposition resulting from the flooding were found within the study area. These features, including plunge pools, linear grooves and flood deposits, were exclusively found in a small area located next to the breached levee and were parallel to the main flow direction. Plunge pools, scoured by the flooding water, were several meters deep, 100 m wide and found at the toe of the breached levee's back slope (at P5 in Figs 3A,C and 4E). Roads and houses close to the plunge pools were completely destroyed and swept away. Adjacent to the plunge pools, numerous well-developed linear grooves were observed (Fig. 4D). The linear grooves were orthogonal to the Kinu River and found in a zone that extended for 250 m along the direction of flow. These grooves were observed at stations N1–7 along Transect N, and between the plunge pools and station S1 along Transect S (Fig. 3B,C). In the linear groove zone, up to 1 m of the pre-flood soil was laterally eroded, causing the underlying semi-consolidated muddy floodplain deposits to be exposed. Linear grooves that were several tens of centimeters deep and wide were dug further into the floodplain deposits as scour marks. The erosional surface was covered by either a thin mud drape (generally less than 1 cm thick; at N2–5; Fig. 3B) or by a thicker sandy flood deposit (generally several centimeters thick, with a maximum depth of 10 cm; at N1, N6–7; Figs 3B and 5). The flood deposit was limited to the area surrounding N1, N6–15 and S1–6 (Figs 3B,C, 5 and 6). In some places (N2–5, S7–8), only a thin mud drape overlay the surface. Bedforms such as unidirectional current ripples and dunes were widely found at the surface within the study area (Fig. 4C). At the midpoint between S4 and S5, the bedforms comprised a stepwise architecture resembling a deltaic lobe ranging heights comprised between 20–30 cm (Figs 3B,C and 4F).

Sedimentary and erosional features found in the flood deposits were laterally variable across the study area (Fig. 3C). The basal unit of the flood deposit was only found at three stations along Transect S. The lower unit was generally confined to areas distant from the breached levee, whereas the upper unit was generally confined to areas close to the breached levee. The lower unit of the flood deposit was found at stations N8–15 and S1–8, while the upper unit was found at stations N1, N6–10, and S1–4 (Figs 3B, 5 and 6). The latter overlapped the former at N8–10 and S1–4 where they showed a vertical stacking pattern with lateral offset. Abrupt lateral changes in thickness and sedimentary features were occasionally found in the two units. With increasing distance from the Kinu River, the

lower unit showed a slight thinning trend, while the upper unit showed a slight thickening trend along both transects (Fig. 3C). Along Transect N, the lower unit thinned from 28 cm at N8 to 17 cm at N15, while the upper unit thickened from 3 cm at N1 to 12 cm at N10. Along Transect S, the lower unit thinned from 16 cm at S1 to 7 cm at S6, while the upper unit thickened from 8 cm at S1 to 22 cm at S6. At stations N9 and N11, the lower unit was characterized by a series of graded layers, although more commonly, a single inversely-graded layer was present (Fig. 5). In general, the upper unit consisted of a sandy graded layer. However, at stations N1 and N6, the upper unit consisted of either a thin muddy-sand or a sandy-mud layer and transitioned into gravelly sand at station N7 (Fig. 5).

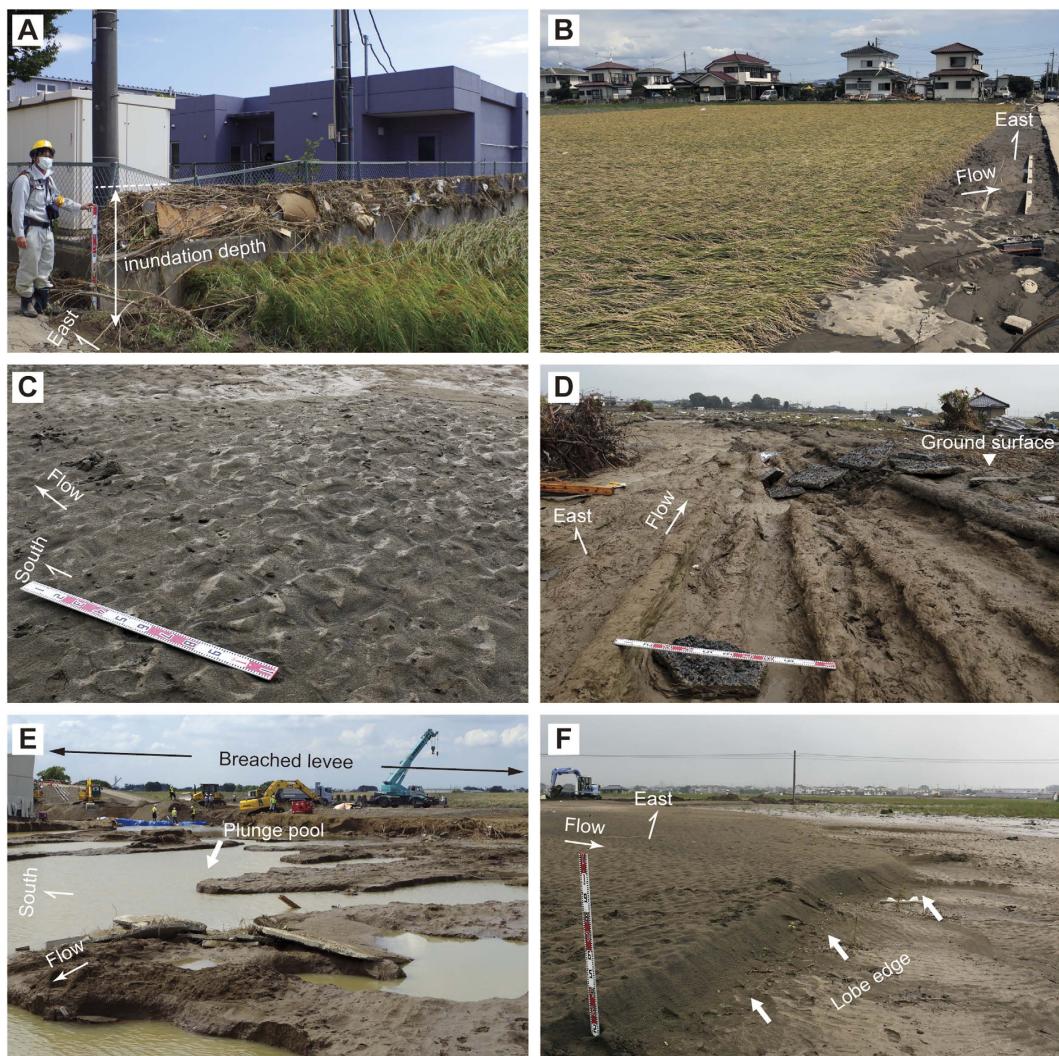
Figure 4. Photographs of the study area. Locations are shown in Fig. 3A (P1–6). The scale bar in panels A, C, D and F represents 1 m. (A) Water-borne debris on the fence at P1 showing the inundation depth of flooding. **(B)** Leaning rice plants showing the direction of flooding water at P2. **(C)** Ripple marks on the surface of the flood deposit indicating the flow direction at P3. **(D)** Linear grooves along the flow direction at P4. **(E)** Plunge pools scoured by the 2015 flood just behind the breached levee at P5. **(F)** Lobe edge of the flood deposit at P6.

The latter could be divided into three sedimentary units based on depositional features and grain-size. The basal unit consists of a muddy deposit, while the lower and upper units consist of sandy material. The basal unit contained abundant plant fragments and a higher mud content compared to the other units at S3–5 (Figs 3B and 6). In general the lower and basal units were characterized by distinct inverse grading although normal grading on a smaller scale was observed in some places. (Figs 5 and 6) Parallel laminations with a slightly higher mud content were present with an upward-decreasing trend within the lower unit. At some stations, the lower unit contained small-scale cross laminations, mud clasts and gravel grains. By contrast, the upper unit generally consisted of coarser sand and a slight fining trend in grain size (Figs 5 and 6). Sedimentary structures in the upper unit were variable and include parallel laminations and distinct large-scale cross laminations which reached a thickness of 20 cm at station S4 (Figs 3B and 6). Mud clasts, gravel and a thin mud drape and/or surface ripple marks were also common (Fig. 4C).

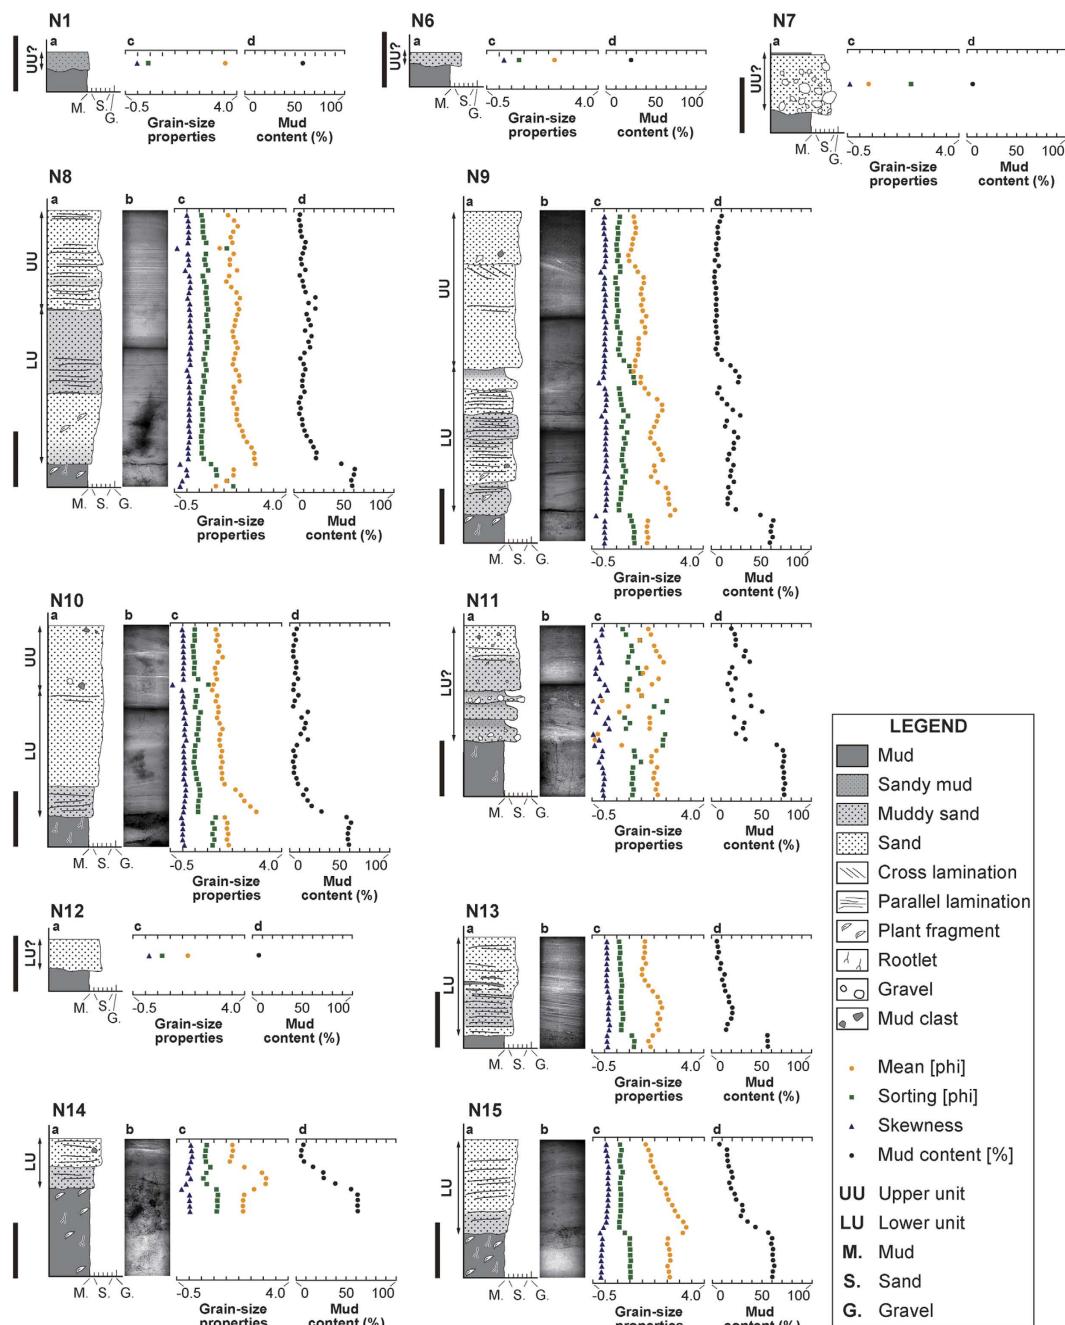
Figure 5. Schematic column (a), soft X-ray image (b), graph of grain-size properties (mean, sorting and skewness) of the particles larger than $63\text{ }\mu\text{m}$ (c), and mud content (d) of the flood deposit along Transect N (N1, N6–15). The scale bar beside each column represents 10 cm.

higher mud content of 62.55% (Figs 5 and 6). Soft X-ray radiography indicated the presence of mud clasts, gravels, and parallel and cross laminations at various depths in the flood deposits. (Figs 5 and 6).

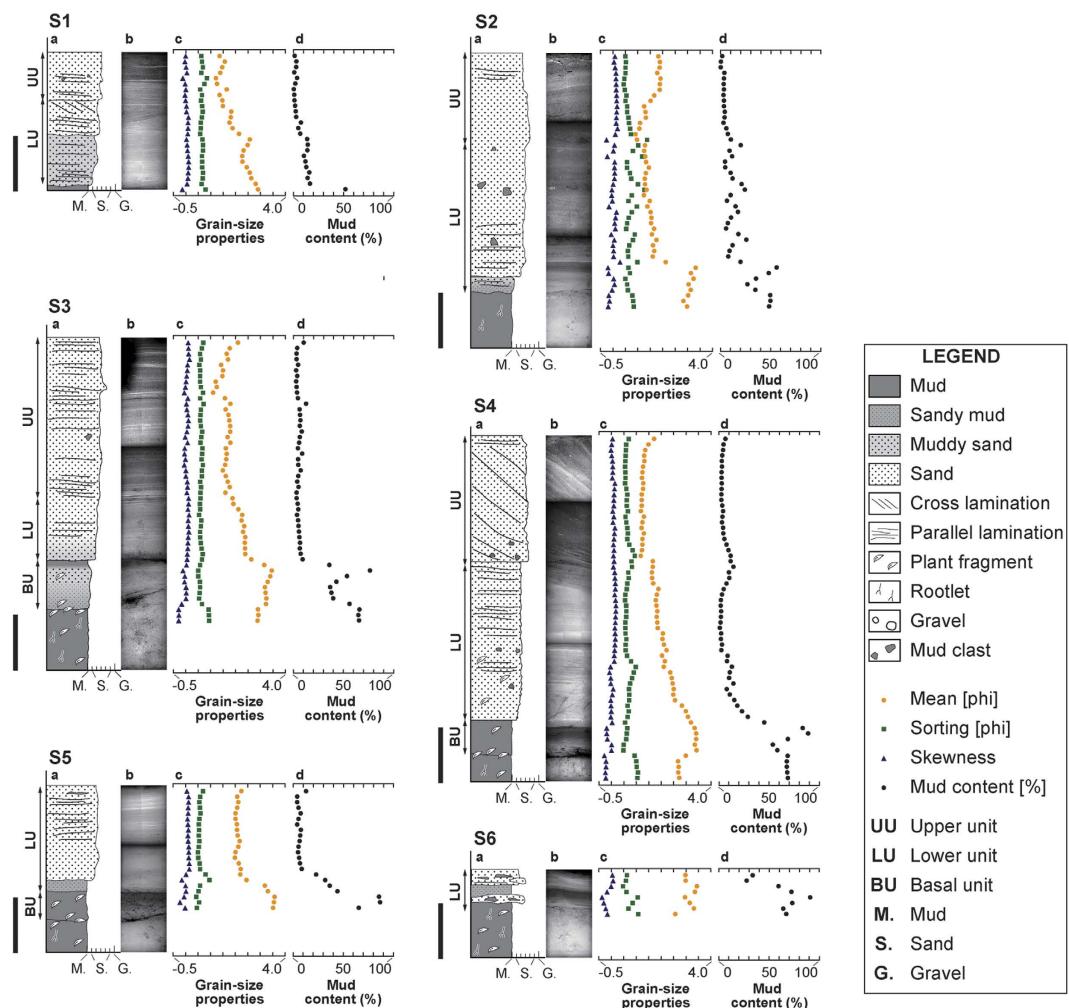
Figure 6. Schematic column (a), soft X-ray image (b), graph of grain-size properties (mean, sorting and skewness) of the particles larger than $63\text{ }\mu\text{m}$ (c), and mud content (d) of the flood deposit along Transect S (S1–6). The scale bar beside each column represents 10 cm.

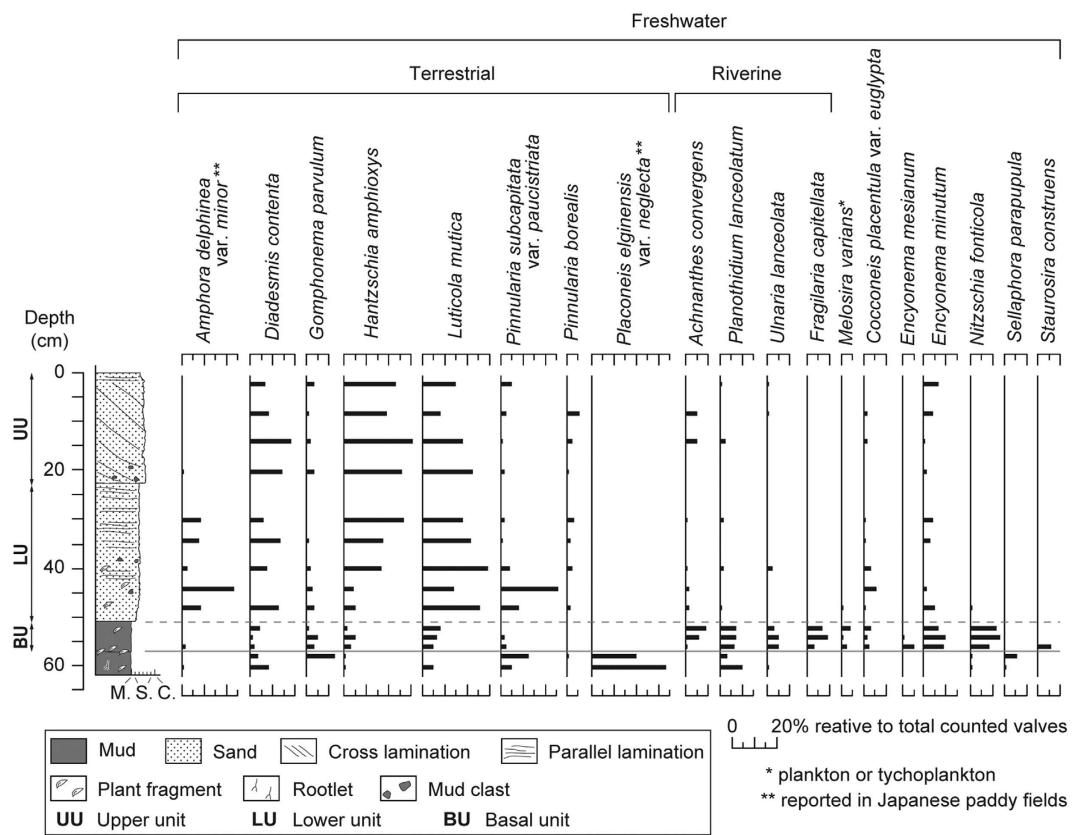
Figure 7. Diatom assemblages for the flood deposit at S4 showing changes in the relative abundance of the dominant species.

Diatom analysis for the deposit found at station S4 revealed that freshwater species were generally dominant, but the species composition of the assemblages varied as a function of the sedimentary facies (Fig. 7). The underlying soil contained many freshwater terrestrial taxa such as *Placoneis elginensis* var. *neglecta*, *Pinnularia subcapitata* var. *paucistriata*, and *Gomphonema parvulum*. These assemblages abruptly changed at the contact between the underlying soil and the muddy basal unit. The basal unit was characterized by riverine benthic diatom species (*Planothidium lanceolatum* and *Ulnaria lanceolata*)¹⁵, other freshwater species, and a decrease in terrestrial taxa

(*Diadesmis contenta* and *Gomphonema parvulum*). In the sandy lower and upper units, diatom assemblages were dominated by terrestrial taxa (e.g. *Diadesmis contenta*, *Hantzschia amphioxys*, and *Luticola mutica*).

Distinct changes in diatom assemblages are recognized within the deposit at S4. The muddy basal unit of the flood deposit is characterized by a mixture of benthic, planktonic riverine and terrestrial freshwater diatom species. These assemblages were likely to be formed from suspended load due to the initial overtopping of the levee. Because diatom valves are known to exhibit the same depositional behavior as that of silt-sized sediment grains, the dominant species were probably incorporated with the fine fractions of the deposit. The sandy lower and upper units of the flood deposit were dominated by terrestrial diatom species (*Diadesmis contenta*, *Hantzschia amphioxys*, and *Luticola mutica*). Such species are commonly found on the surface of wet soils and mosses, but not in coarse-grained sediments^{28–30}. This implies that living diatoms were transported from their original habitat, or pre-existing valves that were buried in soils were scoured, and incorporated with flood sediments during high-energy inundation flow. The observed difference in assemblages can be attributed to the different origins and transportation processes, which are consistent with the depositional processes deduced from the sedimentary features.
