# Single Event Upsets and Hot Pixels in Digital Imagers

**Abstract**— From extensive study of digital imager defects, we found that permanent “Hot Pixels” are the main long term digital camera defects, and are caused by high energy cosmic ray particles. Clearly, as in other microelectronic integrated circuits, most of the particles do not induce permanent damage but instead, inject a short term charge that may cause a transient fault, known as a Single Event Upset (SEU). Unlike standard digital ICs, pixels in a digital imaging sensor can be monitored at almost any desirable frequency. Since an SEU manifests itself as one or more brighter pixels in an otherwise dark image, the rate of SEUs can be measured at a considerably higher accuracy by taking dark-field pictures at different exposure times and different frequencies. In this paper we describe an experimental approach to measuring the occurrence rate and resulting characteristics of SEUs. The SEU rate that we have observed for digital imagers, of about 4 SEUs for every 30 seconds, is considerably higher than was previously reported for ordinary ICs. For the same imager, permanent hot pixels have a rate of 1 every 12.6 days, whi

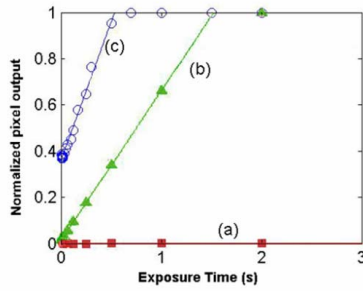
standard hot pixel has a dark response that has an illumination-independent component that increases linearly with exposure time, and can, therefore, be identified by capturing a series of dark field images at increasing exposure times. Figure 1 displays the dark response of a hot pixel, showing the normalized pixel illumination versus the exposure time, where illumination level 0 represents no illumination and level 1 represents saturation. Three different pixel responses are shown in Figure 1. Firstly a good pixel is displayed as curve Fig. 1(a). Since there is no illumination, we expect the pixel output to be constantly zero for all exposures. The other two curves depict the two different types of hot pixels [5]. Curve Fig. 1(b) is a standard hot pixel which has an illumination-independent component that increases linearly with exposure time. The third response shown as curve Fig. 1(c) is a partially stuck hot pixel which has an additional offset that manifests even at no exposure.

Figure 1: Comparing the dark response of imager pixels (a) good pixel, (b) standard hot pixel, (c) hot pixel with offset.

The dark response equation in Equation (2), sometimes called the combined dark offset, is linear. Thus, the parameters  $R_{dark}$  and  $b$  can be extracted by fitting the pixel response in a dark frame vs. exposure time, as seen in Figure 1. For standard hot pixels,  $b$  is zero. These hot pixels are most visible in longer exposures as they do not have an initial offset. In the partially stuck hot pixel case, the magnitude of  $b$  affects the response. This defect will appear in all images. Obtaining this data for each camera involves typically 5 to 20 calibration

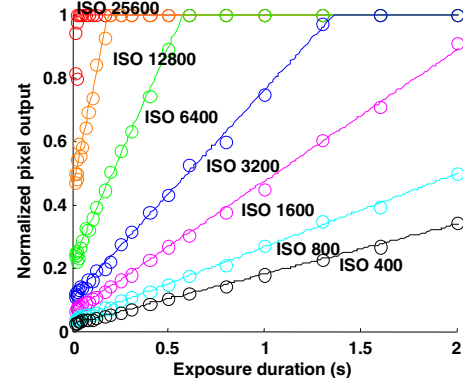
Figure 2: Dark response of a hot pixel at various ISO levels

Figure 2 shows the dark response of a hot pixel that we have measured for varying ISO levels. For low ISO, defects have low values of  $R_{dark}$  and  $b$ . Both  $R_{dark}$  and  $b$  increase dramatically, as the ISO amplification increases, scaling linearly with the ISO (see Equation (1)). In fact, at ISO 12800, the dynamic range of the pixel is reduced by 40% solely due to the offset  $b$ , and at ISO 25600 the pixel is near saturation at all exposures. The high number of hot pixels with offsets suggests that the development of stuck high pixels in the field may actually be due to the presence of hot pixels with very high offsets. This is consistent with our experience of not having detected a true stuck pixel in any of our cameras, while explaining the cameras developing stuck pixels discussed in camera forums.

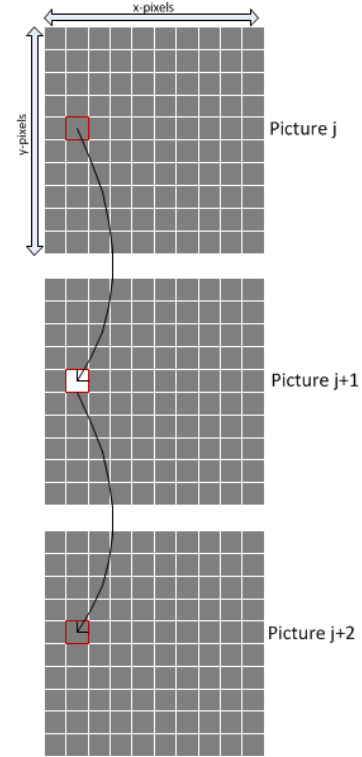
This algorithm can be clearly seen in Figure 3. One thing to note is that our algorithm ignores locations where known hot pixels resided. Given our previous research with hot pixels on this particular imager, the hot pixel locations were known and were not used in the analysis in order to avoid any false positive results.

Figure 3: SEU Detection Algorithm demonstrating an SEU that was detected in image 'j+1' and not present in images 'j' and 'j+2'

- Flag any pixels that have a pixel increase from image  $j$  to image  $j+1$  using a predetermined threshold
- Using the pixel locations from the previous step, check to see if any of them have a decrease in pixel values from image  $j+1$  to image  $j+2$  using the same predetermined threshold
- If any pixel location satisfies the above conditions, it is marked as an SEU defect location

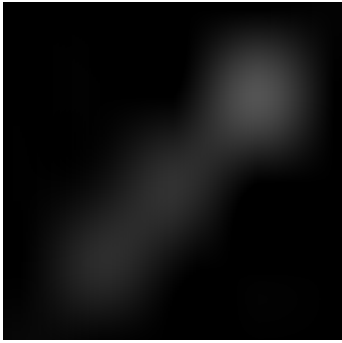
As a starting point we began at ISO 6400, performing experiments at 30s, 10s, 3.2s and 1s. For each experiment about 100 images were taken. During our first set of experiments, we have discovered several interesting forms of SEU defects, specifically SEU streaks. An example is shown in Figure 4. In this example, an incident cosmic ray has hit the imager at a low angle, depositing a charge covering 3 neighboring pixels in a line. We consider this a single particle hit as the cause of this streak is likely a single SEU. We justify this by noting that the event rate (at most a few SEUs per a 21 megapixel image) is such that the probability of 3 events occurring as neighbors is extremely low. Moreover, such streaks turned out to be a common occurrence. These streaks are really the charge equivalent of the trails left by cosmic ray particles in the classic cloud chamber detectors.

Figure 4: Simple SEU Streak (snapshot of 5x5 pixels in size)

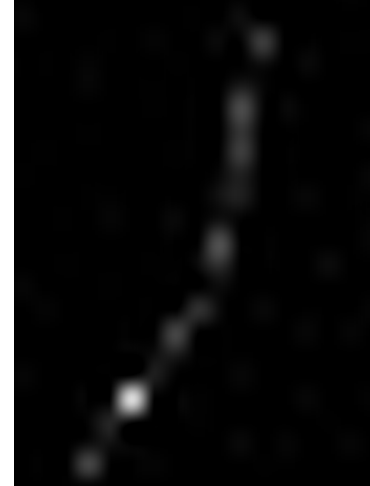
A more complicated streak is shown in Figure 5. In this example, it is clear that the incident cosmic particle began at a particular direction. However, at some point, it incurred a deflection. One possibility is that the incident cosmic ray particle collided with an atom, causing the particle to deflect and creating this interesting SEU defect. From the figure it is clear that there are gaps in the streak which are likely due to some pixels not accumulating enough charge from the incident particle to show the SEU brightness.

Figure 5: Complex SEU Streak (snapshot of 12x17 pixels in size)

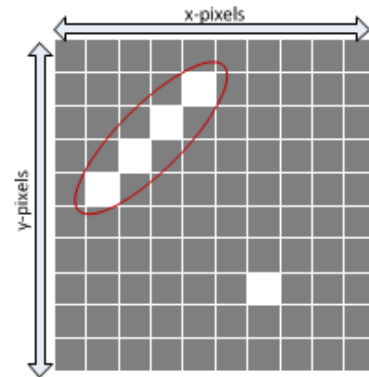
With this complex observation of streaks with inherent gaps, we upgraded our algorithm to consider a streak as a single SEU hit. This method also took into account streaks that had gaps. This enables us to effectively treat an SEU that created a multiple streak as one single event. Such a streak is shown in Figure 6 in which the streak circled in red is considered as a single SEU hit. The figure also shows a simple SEU defect that is only detected at a single pixel spot

Figure 6: SEU types – simple SEU spot (bottom) and SEU cluster (top)

Using the data obtained by our experiments we can now attempt to define certain trends and rates of SEU growth at various operating conditions of the imager. We have counted SEUs that appear in streaks as a single defect as shown in Figure 6. Figures 7 – 10 display the defect count distribution for each exposure time for the ISO 6400 experiments. In all of the distributions shown,

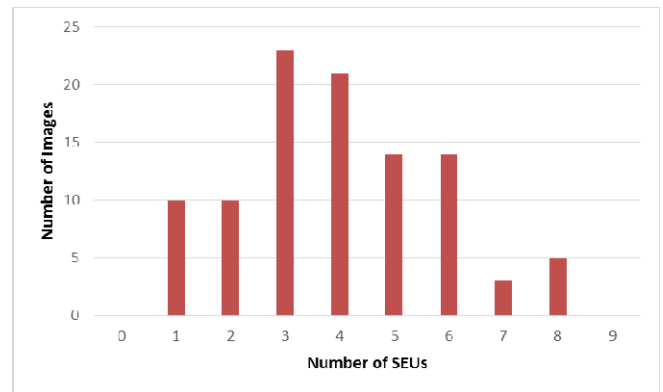
Figure 7: Distribution of number of SEUs per image (ISO 6400, t=30s)

These results indicate, as is expected, that the defect rate increases as the exposure time increases. For radiation type events, a common assumption is that their number follows a Poisson process as shown in Equation 5, where  $\lambda$  is the event rate (per second) and  $\lambda t$  is the expected value of the number of events occurring in  $t$  seconds.

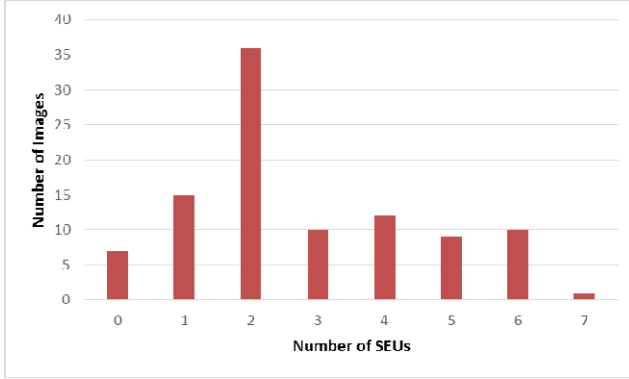
Figure 8: Distribution of number of SEUs per image (ISO 6400,  $t=10s$ )

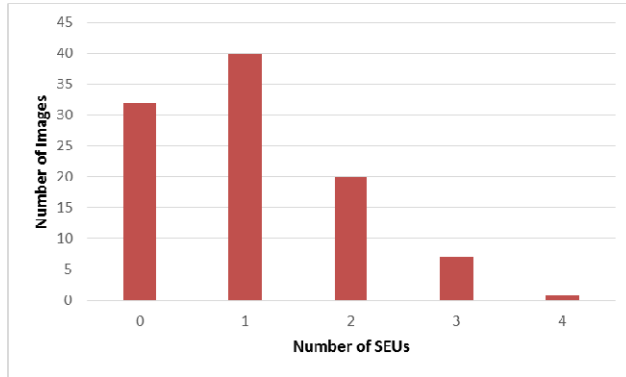
Figure 9: Distribution of number of SEUs per image (ISO 6400,  $t=3.2s$ )

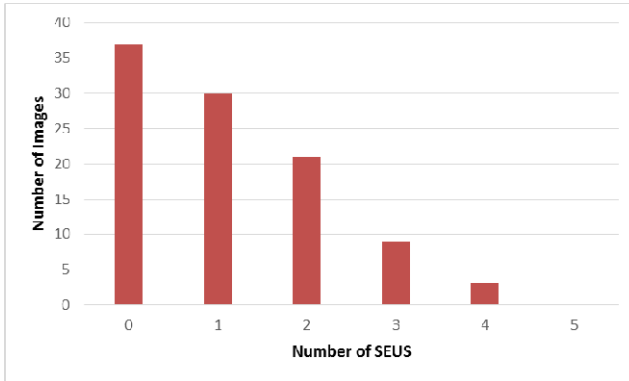
Figure 10: Distribution of number of SEUs per image (ISO 6400,  $t=1s$ )

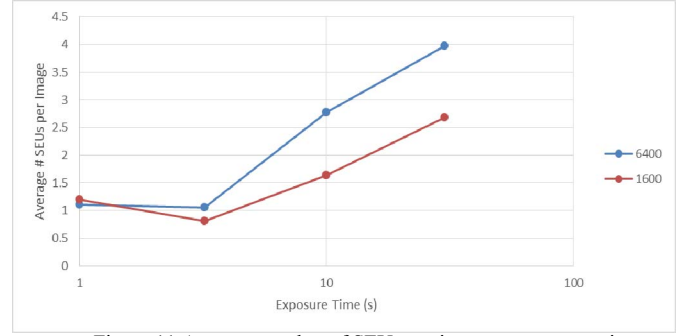
For each value of  $t$ , we estimated the expected value  $\lambda t$ . Figure 11 plots  $\lambda t$  for ISO 6400 and ISO 1600 over a range of exposure lengths  $t$ . Note that in this plot the exposure time is in log scale.

Figure 11 Average number of SEUs per image vs exposure time for 1600 and 6400ISO settings (log scale)

Figure 11 suggests that SEU defect rates increase with ISO. However, this increase is not constant over exposure times. It is clear that for larger exposure times, the increase is greater (with a slope of approximately 0.069 SEUs/second), while for smaller exposure times the difference is much smaller. Also, note that there is a drop in the defect count below the 3.2s exposures for both ISO 1600 and ISO 6400. Though not fully understood at this point, it should be noted that the camera performs some level of background dark frame subtraction around the 1s exposure point. For exposures greater than about 1 s, the camera takes its own dark field image in addition to the exposed image, which is then subtracted from the original data to reduce noise in the image. This subtraction threshold possibly produces the sudden change in the curves at this point

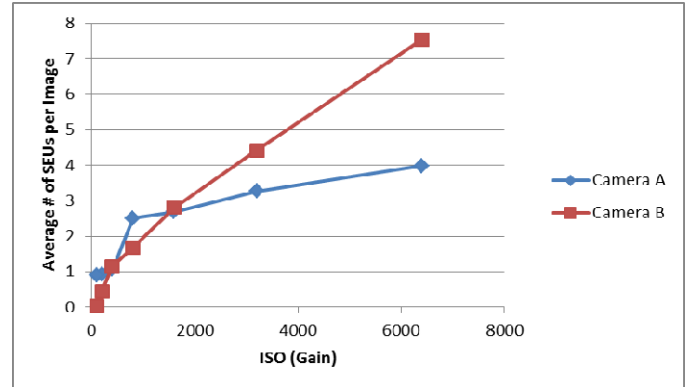
Figure 12 Average number of SEUs per image vs ISO (for a 30s exposure) for 2 cameras scaled to camera A (36x24mm)

To further illustrate the effects of ISO on the defect rate, we plotted the averages  $\lambda t$  for ISO 100, 200, 400, 800, 1600, 3200 and 6400 as shown in Figure 12 for two different imagers. For each ISO, the exposure time was fixed at  $t=30s$ . It is clear that the defect rate increases with ISO. For camera A from ISO 800 onwards the defect rate grows linearly with ISO at  $0.26 \times 10^{-3}$  SEU/ISO. At ISO 400 and lower ISOs the rate suddenly falls showing the gain is too small for many SEU's to be seen above the noise Threshold. An interesting point is that the 400 ISO images do not show the streaks that are seen at higher ISOs. This suggests that there may be several different causes of SEUs (i.e., different cosmic ray particles types creating different effects). The streaks are lower energy events and are therefore not evident in the lower ISOs. Camera B shows a similar behavior, but the linear region starts

at 400 ISO, and the slope is  $1.01 \times 10^{-3}$  SEU/ISO or 4.3x steeper. This may reflect the camera differences, of larger sensor area and smaller pixels (see Table 1). This plot scales the rate to the Camera A sensor size.

The SEU rate that we have observed for digital imagers, of about 4 SEUs for every 30 seconds, is considerably higher than was previously reported for ordinary ICs. Permanent hot pixels for the same imager have a rate of about 1 every 12.6 days by our previous measurements [6], so SEUs are 145,000 times more common. By comparison, for ordinary ICs the literature indicates that SEUs are about 100 times more common than permanent faults. This much higher rate in digital imagers is most likely the result of the much higher sensitivity of pixels to injected charges. However, as Figure 12 suggests, it may also be that imager SEU's are detecting other
